New Whip Planting at Lynnsport - Opinion

Site	Land to the south west of Lynnsport
Date of Issue	11 August 2022
Author	Jonathan Bundock BSc Hons ENV, Cert Arb
Client	Borough Council of King's Lynn and West Norfolk

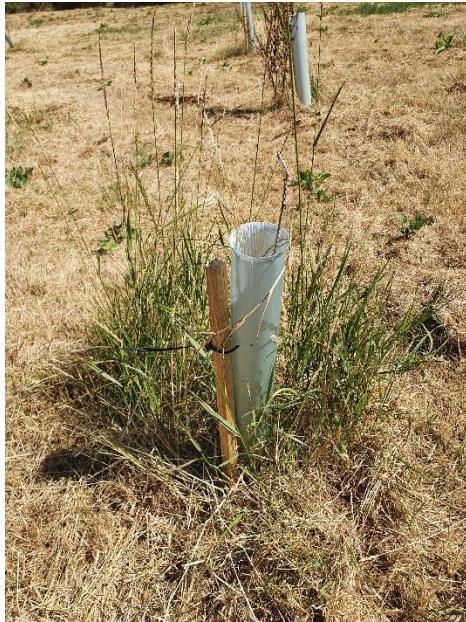
- 3.4 The notch holes in several instances were found to have opened in the dry weather releasing the young tree and exposing the roots to the air.
- 3.5 No mulch or mulch mats were noted. No signs of herbicidal weed suppressant were noted. Competition from weeds and grass was obvious, either around the tree shelters or inside.

Fig 1: Example of unrestricted herbaceous competition around a tube,

- 5.7 Watering and mulching of the plants that appear viable should take place immediately.

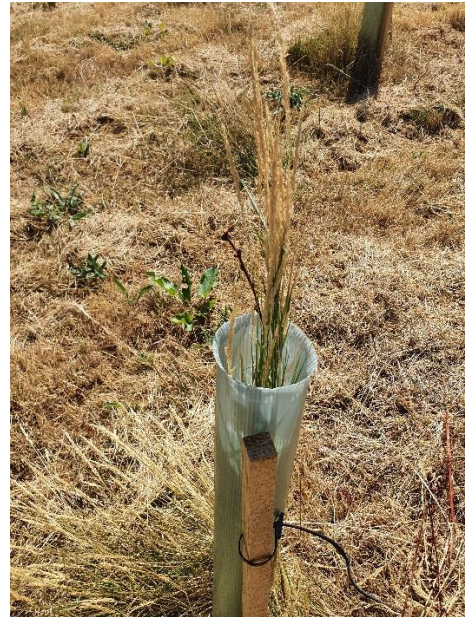
Fig 2: Example of unrestricted herbaceous competition in a tube.

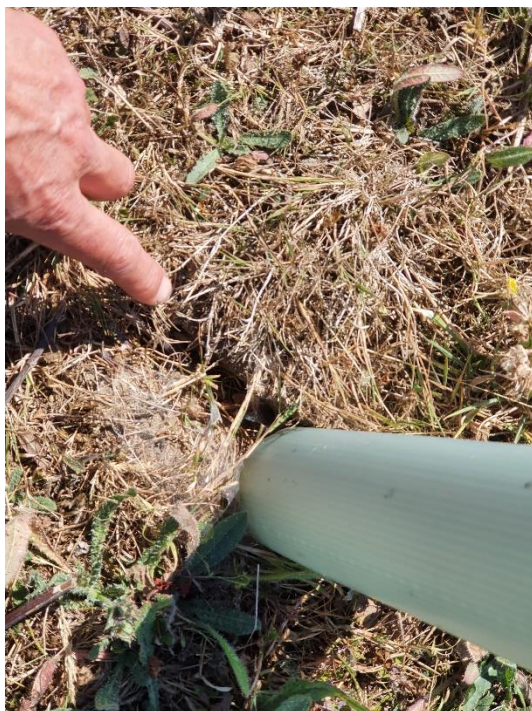
Fig 3: Notch planting holes opening up in the heat.

- 5.1 It has been exceptionally hot and dry in the summer of 2022.
- 5.2 Around 50% of the whip planting may not be viable.
- 5.3 The young trees appear to have been planted correctly however the soil around the notches may not have been adequately heeled down.

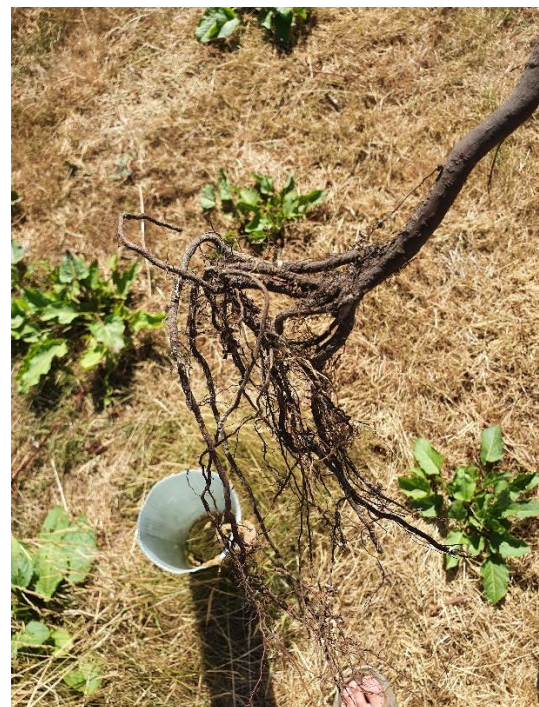
- 3.3 The vast majority of plants were devoid of green leaves. Many trees (up to 50%) were found to be wholly dead, brittle sticks with little chance of recovery. Many of the dead trees could be pulled from the ground with ease.

Fig 4: A young dead plant that was easily extracted from the soil with little resistance.

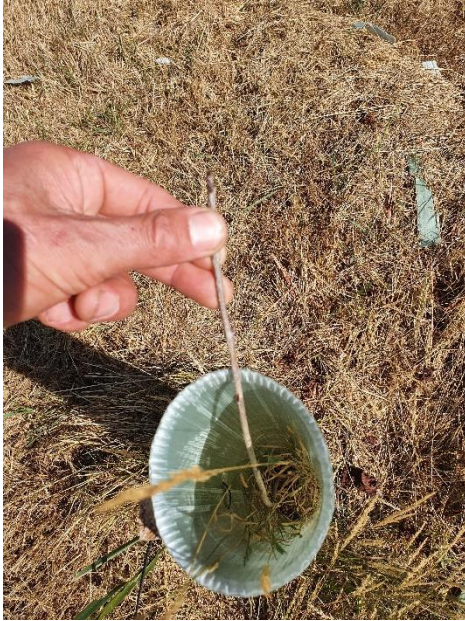
Fig 5: Brown, twiggy, leafless plant with a small degree of flexibility.

- 5.6 Despite a lack of leaves or dead foliage, some of the whips displayed stem flexibility and root sureness which suggests that they may still be viable.

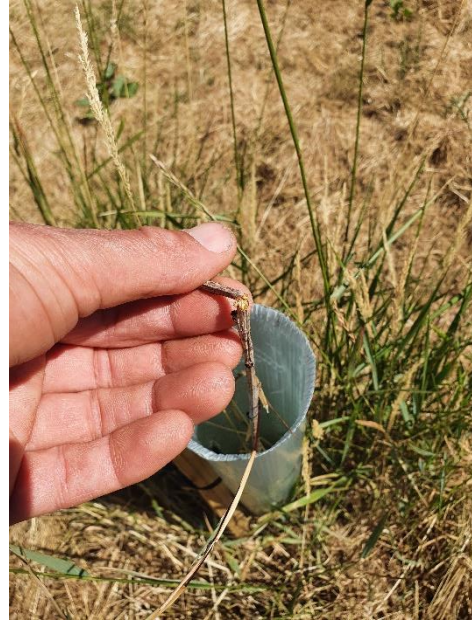
Fig 6: Brittle apex of a wholly dead plant.

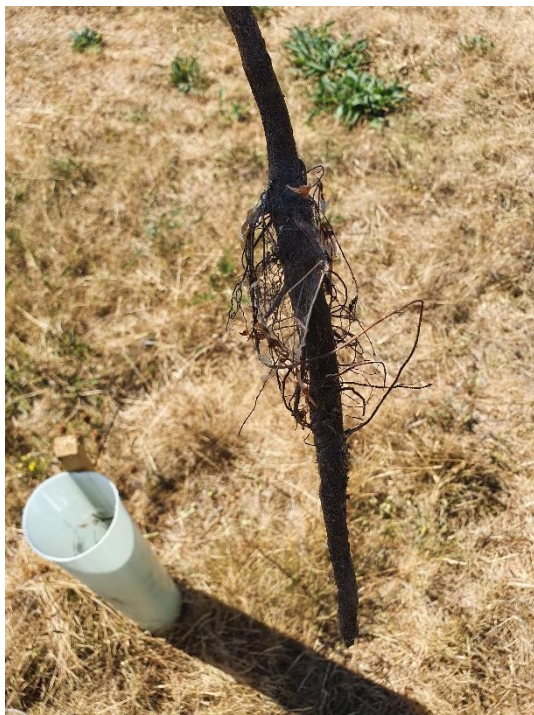
Fig 7: Plant with little or no fibrous roots.

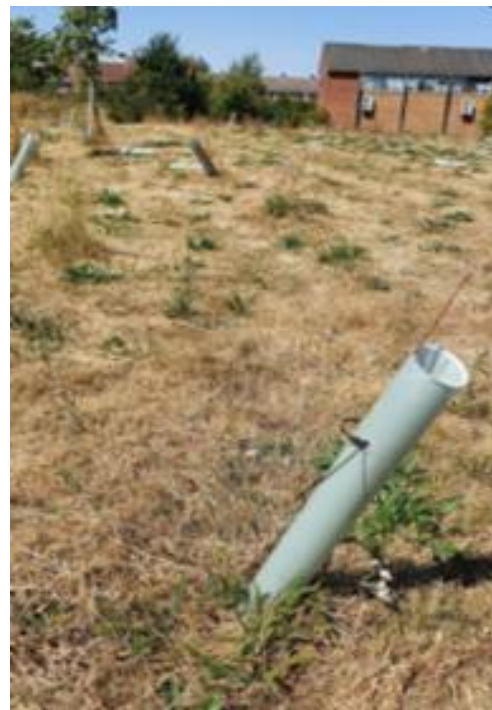
- 3.2 The soil was found to be hard and baked across all of the site. Many tubes were lying on the ground either as a result of having had the stakes removed or broken. In some cases they were leaning despite having a stake attached to the protective tubes.

Fig 8: Unsupported tree shelter.

- 5.5 Regular checking of new planting should be carried out in order to assess the progression of weeds and grasses, check for failures, adjust stakes and ties and keep a note of vandalism. It is not known if that has been carried out. If it has, there should be a record of the condition of the planting.
